Maidstone Borough Council

**Mote Park Lake Reservoir Engineering Services**

**Options Appraisal Report**

April 2018

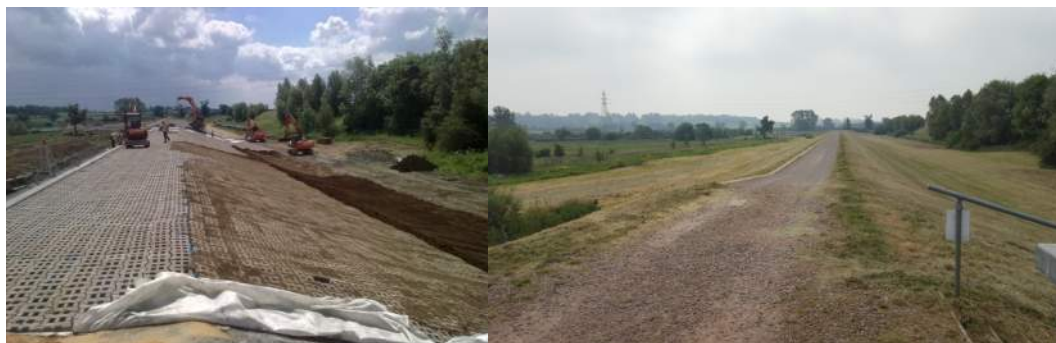
Figure 7-1: Grass Covered Articulated Concrete Block Slope Reinforcement, During Construction (left), Post Construction (right)

Dry-cast interlocking concrete blocks of uniform size and shape will be tied with a matrix of cables to form large mats of blocks, similar to Armorflex by Armortec. The mats will be laid across the embankment in rows. Soil dowels will be provided to resist uplift of the mats. The voids are infilled with a gravel/soil mix. The blocks will then be topsoiled and seeded as required to encourage the growth of grass along the slope. The blocks will provide reinforcement of the slope whilst facilitating a natural appearance.

An example of the use of grass covered articulated concrete blocks to reinforce a spillway is shown in Figure 7-1.

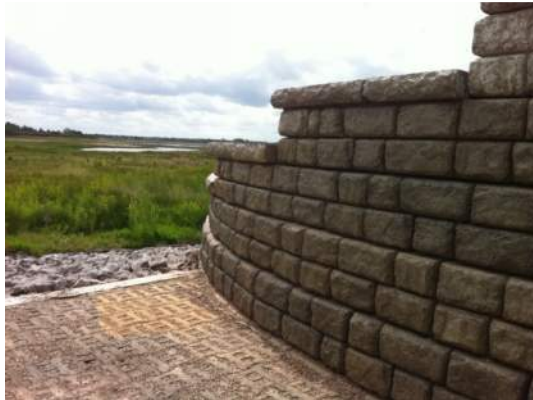
Figure 7-2: Redi-Rock wing wall and Armorflex (photo reproduced with permission of CPM Group)

Various construction options are possible including reinforced concrete, masonry or precast concrete blocks with a textured finish to look like dressed masonry. It is proposed that the walls will be formed using Redi-Rock precast concrete blocks with a Limestone Blockwork finish, or similar. The finish will be confirmed through stakeholder consultation.

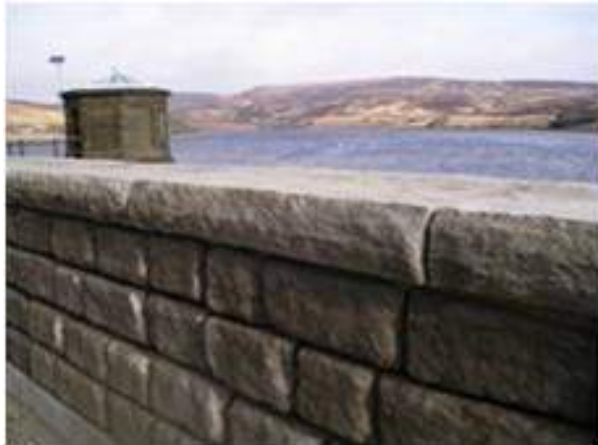
Figure 7-3: Redi-Rock wave wall at Walshaw Dean Reservoir (photo reproduced with permission of CPM Group)

Various construction options are possible including reinforced concrete, masonry or precast concrete blocks with a textured finish to look like dressed masonry. It is proposed that the walls will be formed using Redi-Rock precast concrete blocks with a Limestone Blockwork finish, or similar. The finish will be confirmed through stakeholder consultation. If blocks are used the joints will be sealed. The wall will be supported on a concrete base slab, below finished ground level. Due to the possibly disturbed and sandy nature of the ground under the proposed wall alignment a shallow cut-off may be required

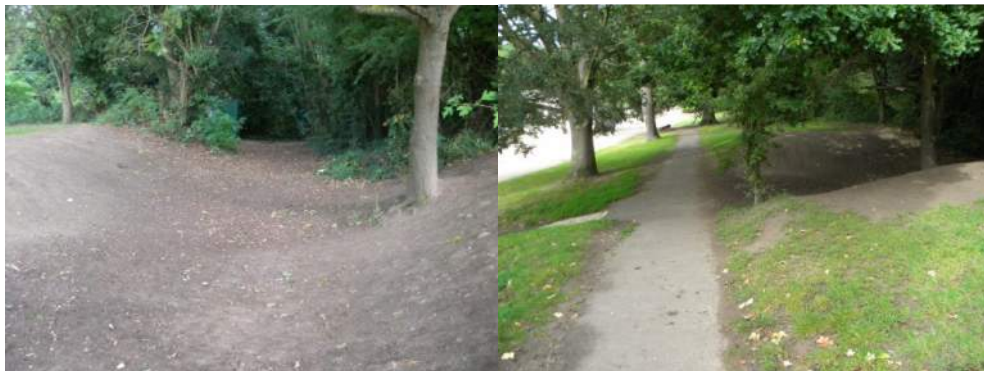
Figure 7-4: Low spot (gully) providing access to Mote Park boat club's storage container

The ground will be raised by approximately 1m to 2m at the right end of the dam to form an earth embankment in continuity with the wave wall. The crest of the new embankment will tie into the top of the wave wall. The embankment will have a trapezoidal section with a crest width of 2m; the slopes will be formed with a maximum gradient of 1 in 3 although can be shallower to fit with the existing landform. This is primarily to infill the gully.

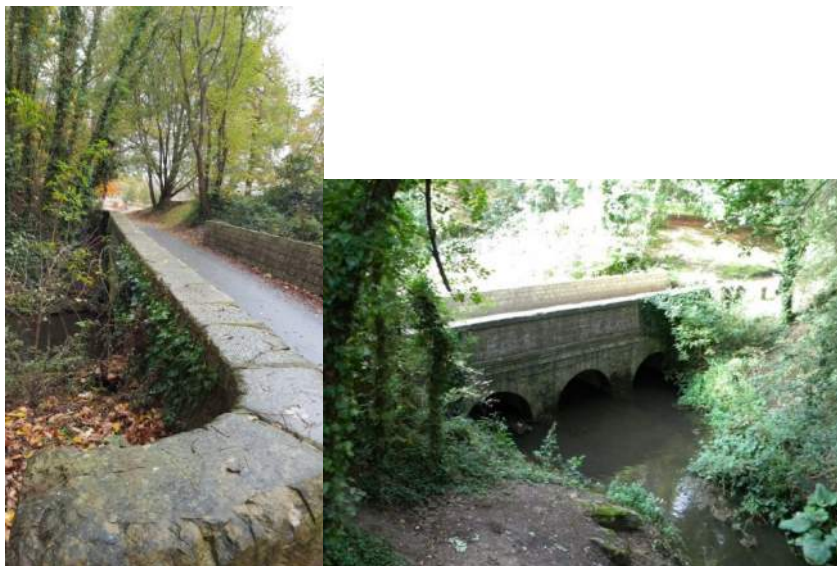
**Figure 7-7: West Drive Bridge showing existing parapet arrangement**

During significant flood events the bridge provides a hydraulic restriction leading to the bridge becoming surcharged. The bridge parapets provide a restriction to flood flows.

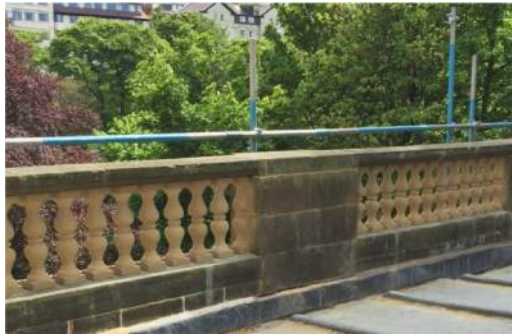
**Figure 7-8: Scarborough parapet balustrading reproduced with permission of Procter Cast Stone**

It is proposed that the linear sections of the parapet wall (approx 15m x 2) is removed and replaced with bespoke heritage type cast stone (or suitably approved equivalent) open balustrades and coping. This will give a small increase in flow, during extreme flood events when the bridge overtops, and should retain an aesthetically pleasing appearance. The curved end sections of West Drive Bridge's parapet wall will be retained. Balustrades will be supplied pre-drilled to accept stainless steel location dowels. A structural assessment of West Drive Bridge, to accommodate the changes will be required.
