Job No. 122775: Mote Park Lake - Landscape and Visual Survey: Photographic Report

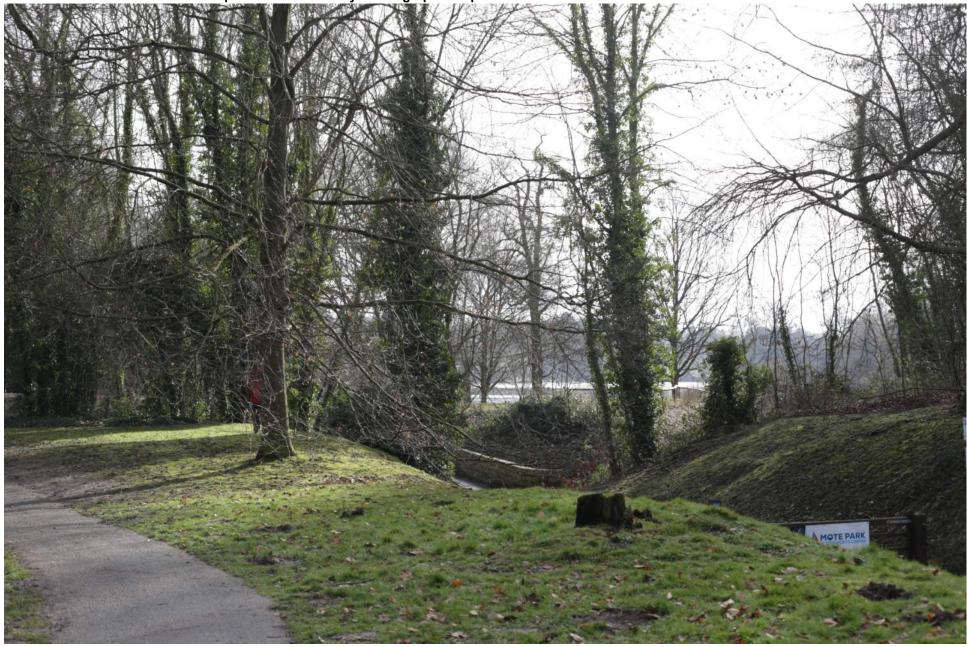
Baseline photograph

View east from main pedestrian access path from Mote Avenue

OS reference: 577252 E 155355 N Eye level: 26.01m AOD Direction of view: 150° Distance to development: 0.07 km Horizontal field of view: 39.6° Principal distance: 500 mm Camera: Canon EOS 6D Lens: 50mm (Canon EF 50mm f/1.4 USM) Camera height: 1.5 m AGL Image: 50mm original photograph Date and time: 06/03/2018 09:26

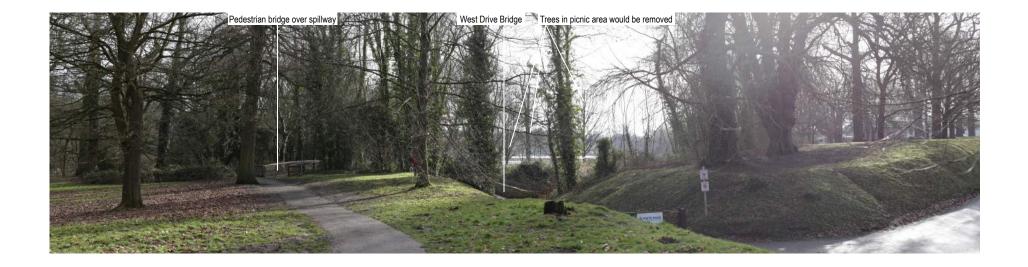
View east from main pedestrian access path from Mote Avenue

Principal distance: 500 mm Camera: Canon EOS 6D Lens: 50mm (Canon EF 50mm f/1.4 USM) Camera height: 1.5 m AGL Image: 50mm original photograph Date and time: 06/03/2018 09:26 ISO: 200 Aperture: f/5.6 Shutter speed: 1/320 sec Panorama 1 is constructed from Photo P1 and adjacent frames

Evaluation: This location is on the main footpath route into Mote Park from Mote Avenue for pedestrian visitors. The view of the lake unfolds as the visitor reaches and crosses the pedestrian footbridge over the existing geliday channel. Existing deciduous trees partially screen views. Removal of trees required for the construction of the new spillway on abutment would reduce the screening effect. This would be a beneficial effect on the sequence of views, creating an enhanced feeling of anticipation for visitors arriving at the northern end of the lake.

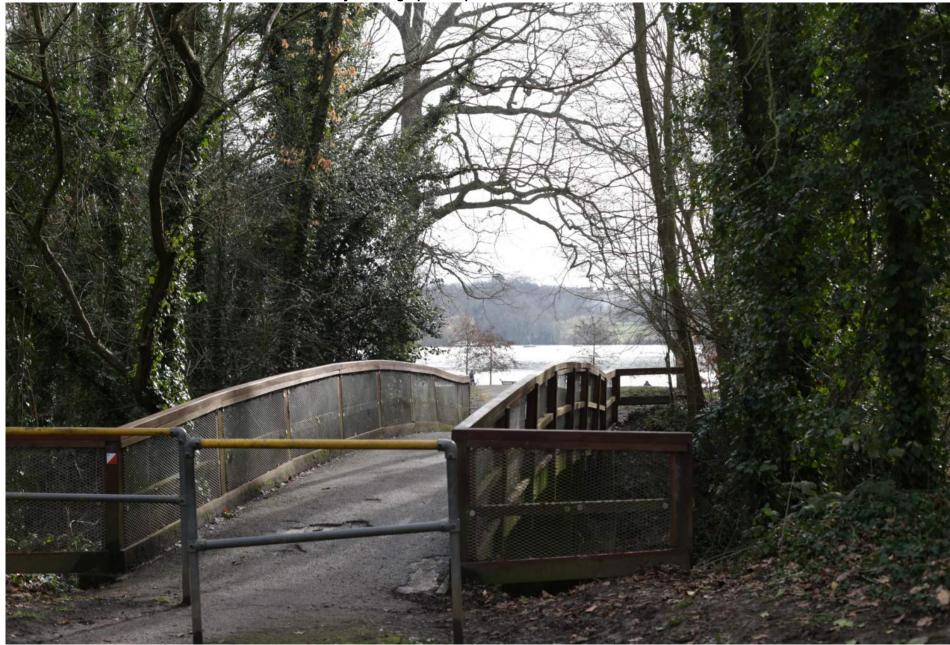
View east from main pedestrian access path from Mote Avenue at the pedestrian footbrige over the existing spillway

OS reference: 577281 E 155352 N Eye level: 25.7m AOD Direction of view: 120°

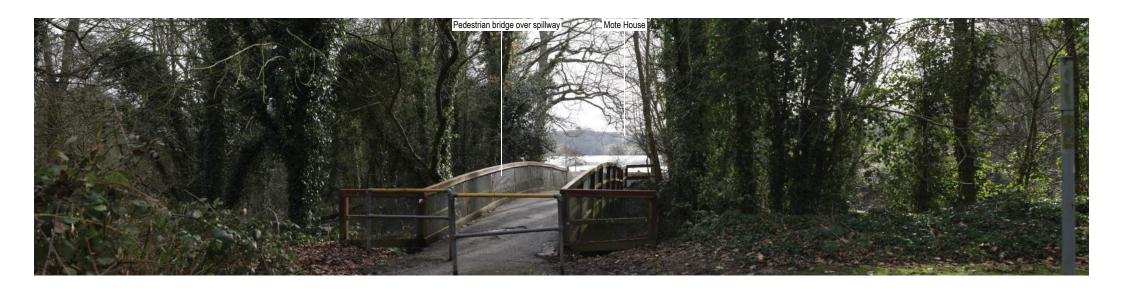
View east from main pedestrian access path from Mote Avenue at the pedestrian footbrige over the existing spillway OS reference: 577281 E 155352 N Eye level: 25.7m AOD Direction of view: 120° Distance to development: 0.01 km Principal distance: 500 mm Camera: Canon EOS 6D Lens: 50mm (Canon EF 50mm f/1.4 USM) Camera height: 1.5 m AGL Image: 50mm original photograph Date and time: 06/03/2018 09:41 ISO: 200 Aperture: f/5.6 Shutter speed: 1/250 sec Panorama 2 is constructed from Photo P2 and adjacent frames

Evaluation: This location is on the main footpath route into Mote Park from Mote Avenue for pedestrian visitors. The view of the lake and Mote House unfolds as the visitor reaches and crosses the pedestrian footbridge over the existing spillway channel. Existing deciduous trees frame the view of the lake and house. Removal of trees required for the construction of the new spillway on abutment would reduce the screening effect, widening the view from this location.

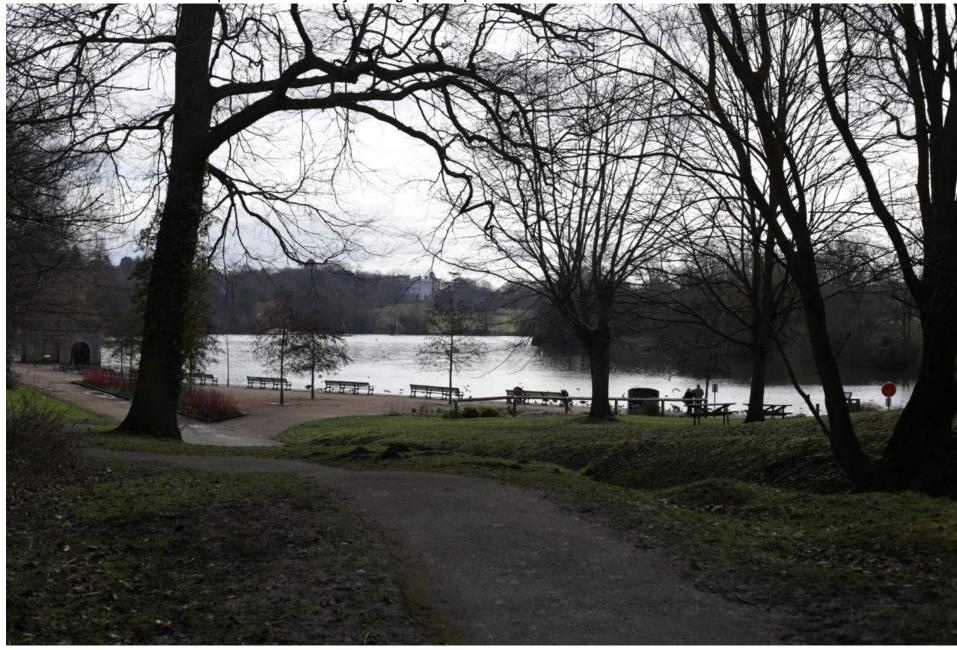
View of Mote House and Mote Park Lake from main pedestrian access path from Mote Avenue looking over the lakeside seating area

OS reference: 577315 E 155346 N Eye level: 23.95m AOD Direction of view: 120° Distance to development: 0.00 km Horizontal field of view: 39.6° Principal distance: 500 mm Camera: Canon EOS 6D Lens: 50mm (Canon EF 50mm f/1.4 USM) Camera height: 1.5 m AGL Image: 50mm original photograph Date and time: 06/03/2018 09:44 ISO: 200 Aperture: f/5.6 Shutter speed: 1/1000 sec

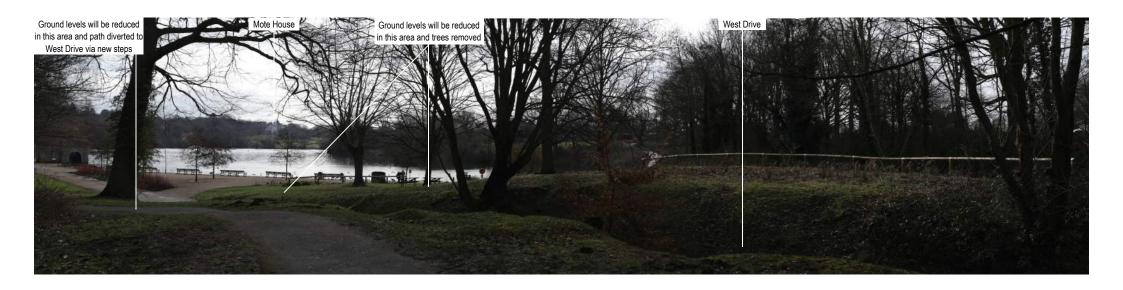
View of Mote House and Mote Park Lake from main pedestrian access path from Mote Avenue looking over the lakeside seating area OS reference: 577315 E 155346 N Eye level: 23.95m AOD Direction of view: 120°

Principal distance: 500 mm Camera: Canon EOS 6D Lens: 50mm (Canon EF 50mm f/1.4 USM) Camera height: 1.5 m AGL Image: 50mm original photograph Date and time: 06/03/2018 09:44 ISO: 200 Aperture: f/5.6 Shutter speed: 1/1000 sec Panorama 3 is constructed from Photo P3 and adjacent frames

Evaluation: This location is on the main footpath route into Mote Park from Mote Avenue for pedestrian visitors. The new lakeside seating area and lake behind undulating topography accommodating access road and footpath are prominent in the view, with Mote House being seen in the distance. The view is framed to the left by the boat house. The proposed spillway will require substantial alteration to levels in the foreground of this view, and the experience for users of the footpath will be significantly changed by re-routing the footpath down steps to the right.

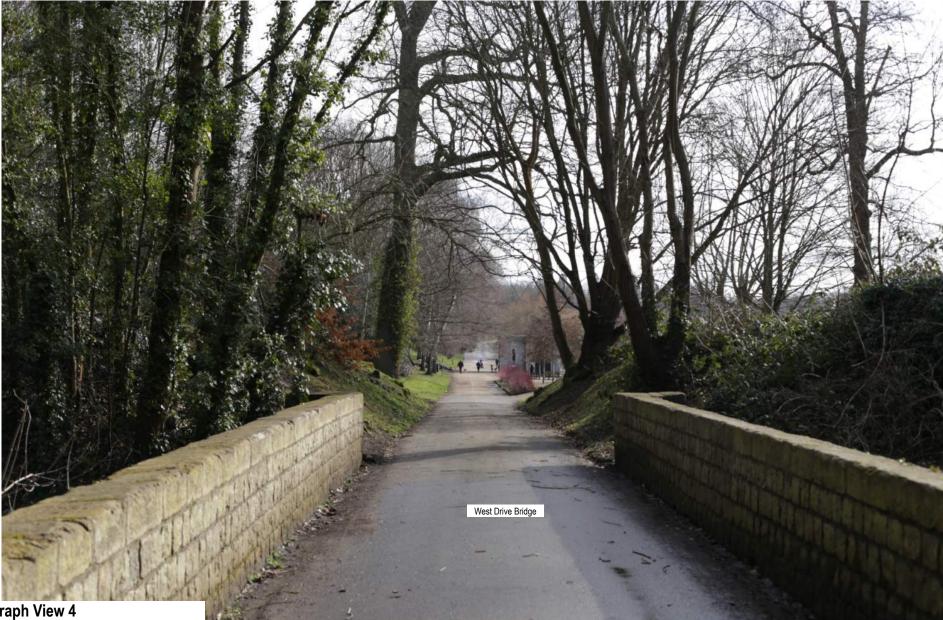
Photograph View 4

View east along carriageway to Mote House from the bridge over the existing spillway.

OS reference: 577301 E 155346 N Eve level: 23.13m AOD Direction of view: 100°

Evaluation: This location is on the historic carriage drive (West Drive) to Mote House from Mote Avenue (currently gated thereby restricting access for pedestrians and vehicles) over the West Drive Bridge. The proposals will significantly reduce levels, removing the embankments on either side of the drive and associated trees. The bridge parapets which currently restrict the flow of flood water need to be altered and cast stone balustrades are currently proposed. The steps diverting pedestrians from the main access footpath will be seen meeting the carriageway to the left. There will be a significant change to the character of this view, with a reduction in the sense of enclosure, introduction of balustrades, and opening up of views of the lakeside seating area. The proposed alteration to the bridge parapet walls will need to be sensitively designed to minimise adverse effects on the character of Daniel Asher Alexander's design.

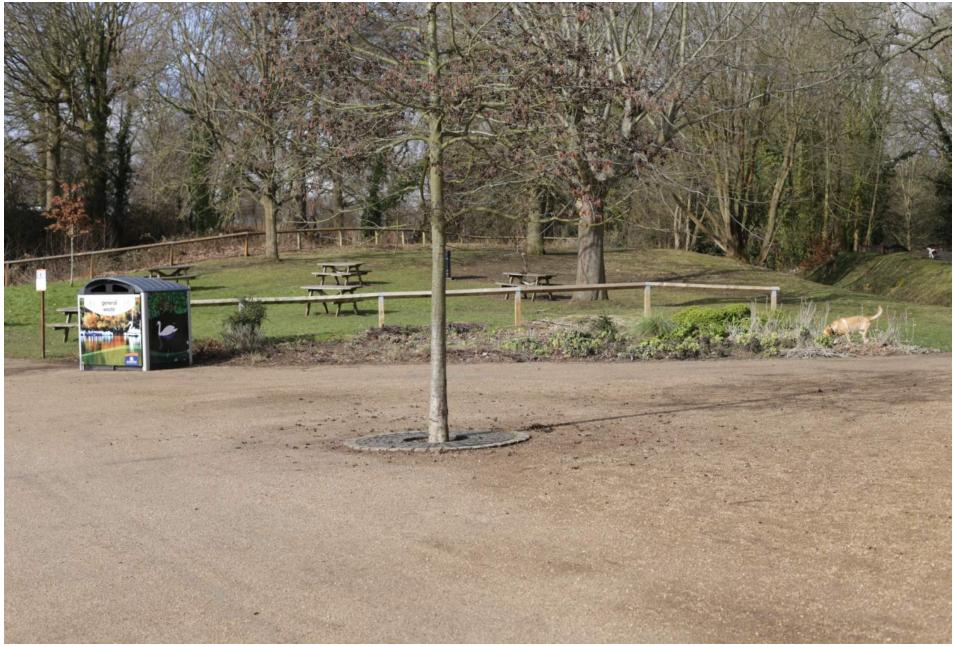
View from lakeside seating area
looking directly at the area affected by
OS reference: 577393 E
Eye level: 21.56m AOD proposal Option C.

OS reference: 577393 E 155322 N Direction of view: 290° Distance to development: 0.03 km

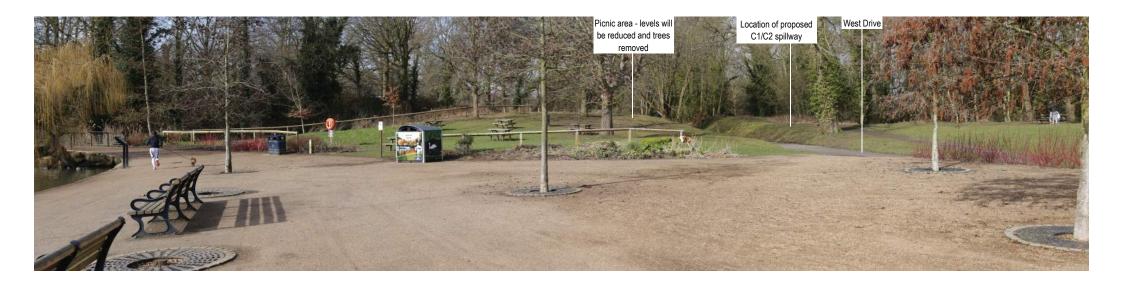
View from lakeside seating area looking directly at the dam abutment and other areas affected by proposal options.

OS reference: 577393 E 155322 N Eye level: 21.56m AOD Direction of view: 290° Distance to development: 0.03 km Principal distance: 500 mm Camera: Canon EOS 6D Lens: 50mm (Canon EF 50mm f/1.4 USM) Camera height: 1.5 m AGL Image: 50mm original photograph Date and time: 06/03/2018 10:00 ISO: 200 Aperture: f/5.6 Shutter speed: 1/640 sec Panorama 5 is constructed from Photo P5 and adjacent frames

Evaluation: The recently refurbished lakeside seating area is one of the main activity hubs of Mote Park, popular all year round with visitors and in close proximity to toilets, cafe and car park. There will be a significant change to levels on the dam abutment for all options, and for Option C1 in particular, there will be substantial reduction in levels (and loss of trees) on the picnic area which currently provides an elevated vantage point. However, the main focus of attention for visitors using the lakeside benches is towards the lake, and away from the areas to be affected by the proposals.

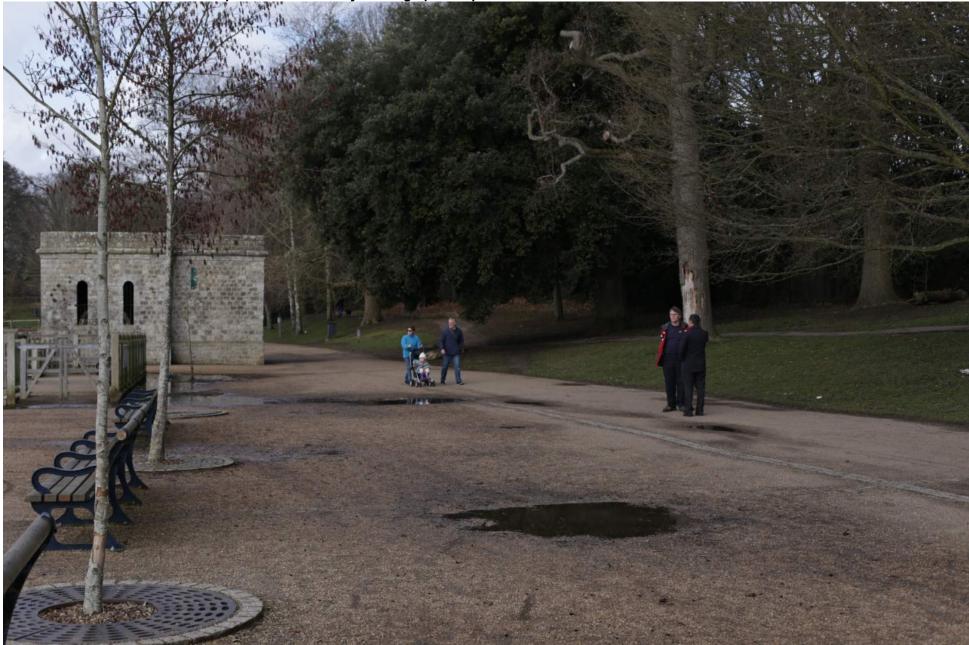
Baseline photograph

View from eastern end of lakeside seating area.

OS reference: 577519 E 155327 N Eye level: 21.47m AOD Direction of view: 330° Distance to development: 0.03 km Horizontal field of view: 39.6° Principal distance: 500 mm Camera: Canon EOS 6D Lens: 50mm (Canon EF 50mm f/1.4 USM) Camera height: 1.5 m AGL Image: 50mm original photograph Date and time: 06/03/2018 10:11 ISO: 200 Aperture: f/5.6 Shutter speed: 1/640 sec

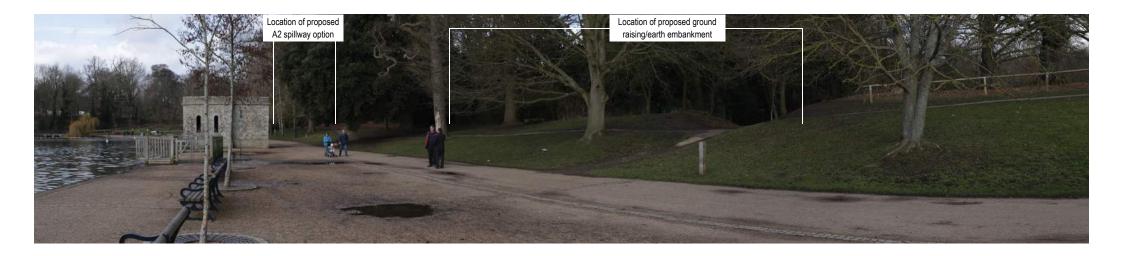
View from eastern end of lakeside seating area.

OS reference: 577519 E 155327 N Eye level: 21.47m AOD Direction of view: 330° Distance to development: 0.03 km Principal distance: 500 mm Camera: Canon EOS 6D Lens: 50mm (Canon EF 50mm f/1.4 USM) Camera height: 1.5 m AGL Image: 50mm original photograph Date and time: 06/03/2018 10:11 ISO: 200 Aperture: f/5.6 Shutter speed: 1/640 sec Panorama 6 is constructed from Photo P6 and adjacent frames

Evaluation: The boat house obstructs the view of much of the area to be affected by Option C1 and C2 from this direction. It is intended to raise levels to fill in the cutting through the embankment on the right, which will result in the loss of some trees. In this location tree planting could be carried out to replace losses over time. The main focus of attention for visitors using the lakeside benches is towards the lake, and away from the areas to be affected by the proposals.

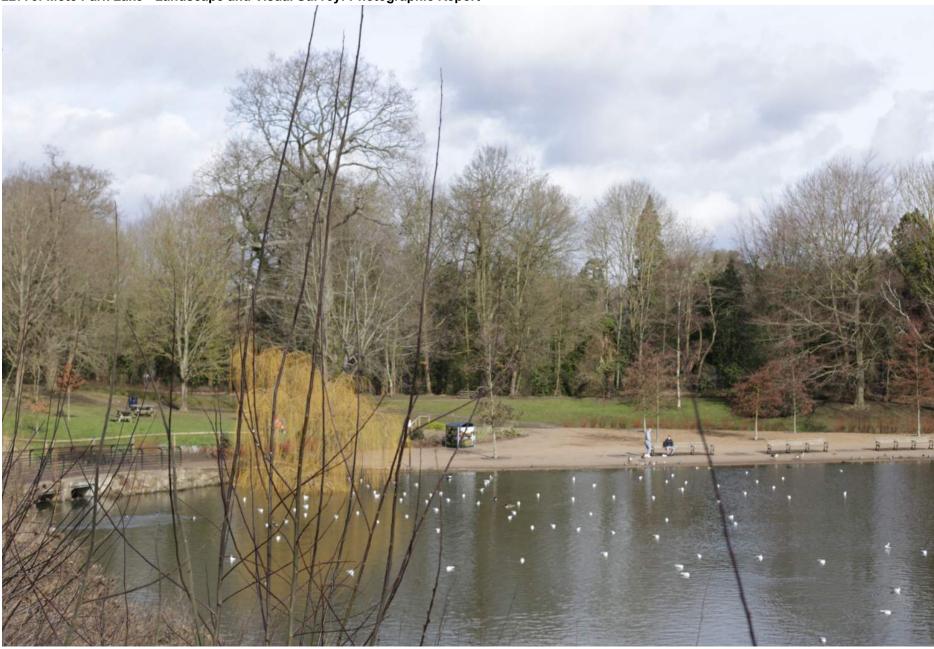
Baseline photograph

View from viewpoint seating area adjacent to elevated footpath connecting lakeside seating area with visitor facilities.

OS reference: 577381 E 155222 N Eye level: 26.46m AOD Direction of view: 30° Distance to development: 0.12 km Horizontal field of view: 39.6° Principal distance: 500 mm Camera: Canon EOS 6D Lens: 50mm (Canon EF 50mm f/1.4 USM) Camera height: 1.5 m AGL Image: 50mm original photograph Date and time: 06/03/2018 10:26 ISO: 200 Aperture: f/5.6 Shutter speed: 1/800 sec

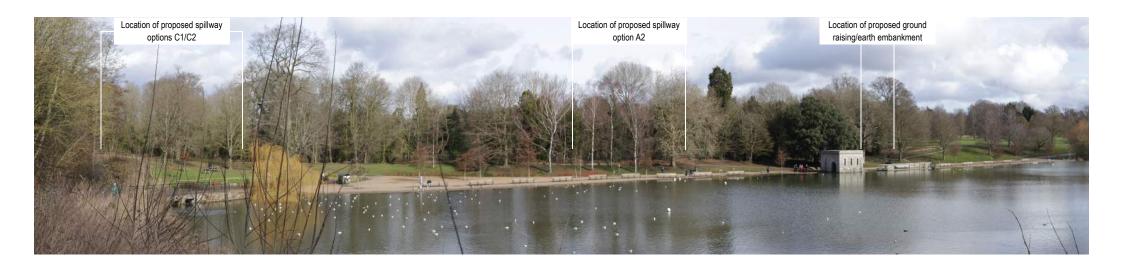
View from viewpoint seating area adjacent to elevated footpath connecting lakeside seating area with visitor facilities..

Camera height: 1.5 m AGL Image: 50mm original photograph Date and time: 06/03/2018 10:26 ISO: 200 Aperture: f/5.6 Shutter speed: 1/800 sec Panorama 7 is constructed from Photo P7 and adjacent frames

Evaluation: The full extent of the proposals for all options will be visible from this vantage point, which gives a clear view in winter of trees along and behind the dam. Changes in level to accommodate the new spillway on abutment and the non-overflow crest (wavewall) will be clearly visible; the former providing an interruption in the curve of the embankment which frames the view of the lake.

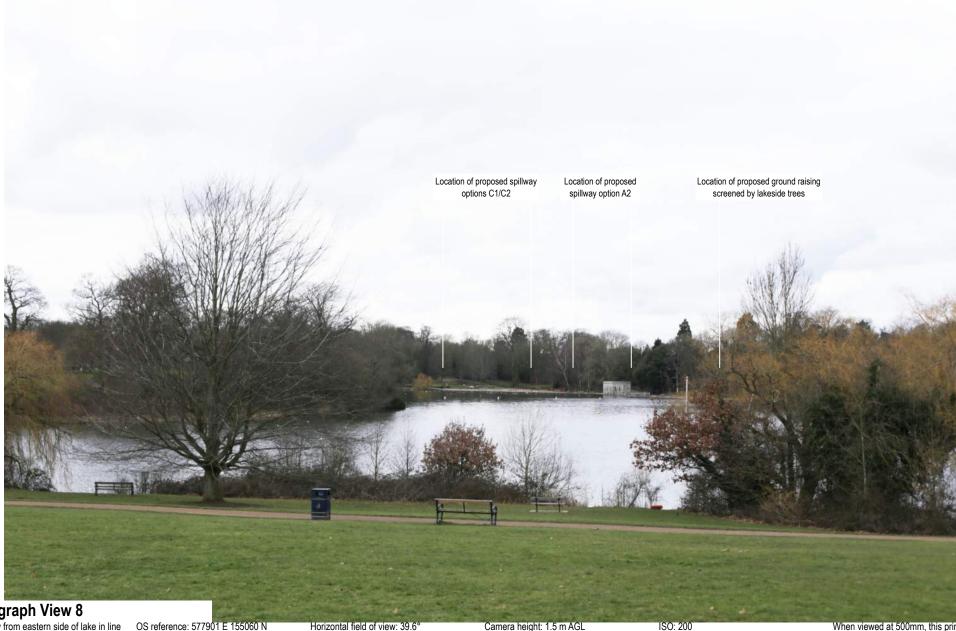
Photograph View 8

View from eastern side of lake in line with Mote House.

OS reference: 577901 E 155060 N Eye level: 28.5m AOD

Evaluation: This view demonstrates the relationship between Mote House and the boat house, forming the westward axis; one of the key components of the design of the park. There will be a clear and direct view of the proposals affecting this historically significant view. Mature and semi-mature tree planting (not visible in view) between this viewpoint and the house (behind the viewer), currently restrict open views at ground level from Mote House. However, Policy 5 of the Conservation Plan promotes the restoration of the structure of the 19th Century Park through new planting and the removal of accretions.

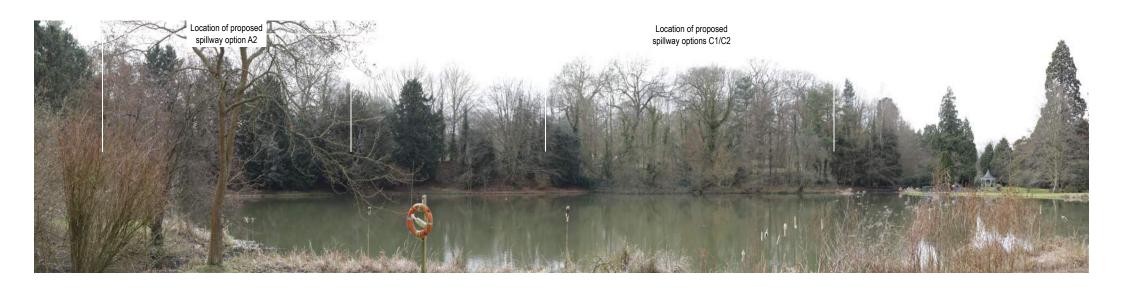
View from Turkey Mill Lake.

Evaluation: Loss of trees associated with the construction of the spillway on abutment will reduce (but not remove) the screening properties of the existing deciduous trees. In winter there are already views through to the north western corner of Mote Park including the car park. Replacement planting will mitigate reduction in screening properties over time. Option A2 + C2 would have a significantly greater effect by the additional removal of mixed deciduous/coniferous trees in the centre of the view.
